## サイドローリングタイプハッチカバーの下降時の開きについて

## チェーン&ワイヤーの調整方法

## Splitting Motion while Jacking down (2)

## Adjustment Manual for Balancing the Tension of Chain & Wire

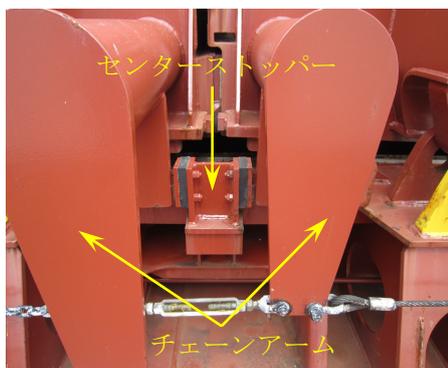
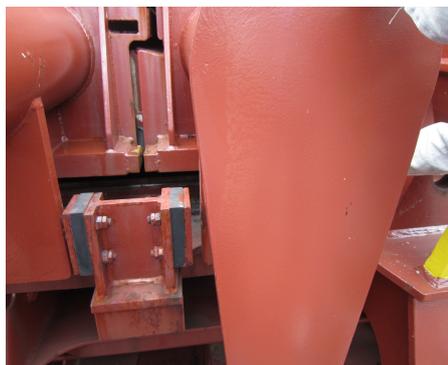
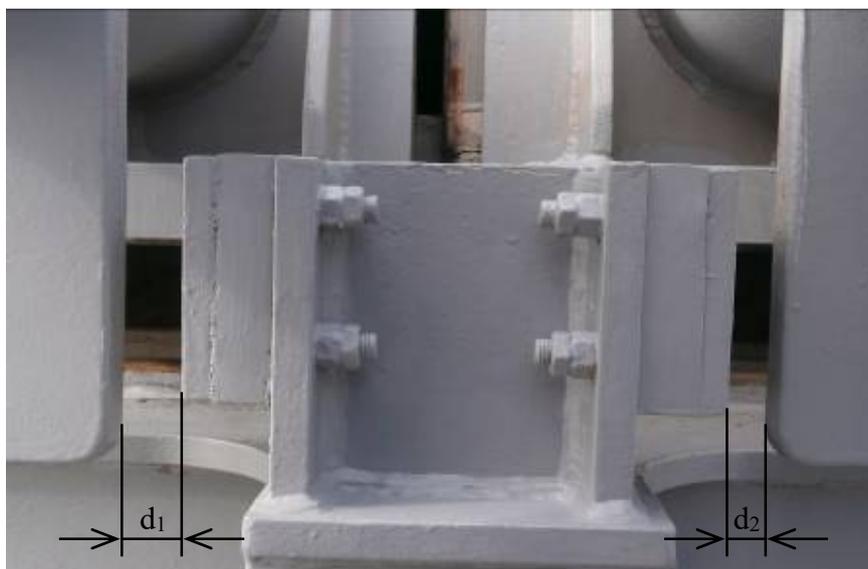
- 1) マニュアルバルブを操作し、左右パネルを引き寄せ、艀艀センターストッパーからチェーンアームまでの距離を確認する。

左上：艀

左下：艀

右：センターストッパーからチェーンアームまでの距離、 $d_1$ 、 $d_2$

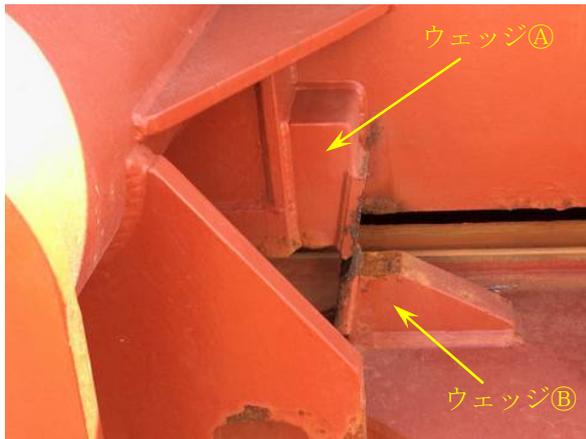
開き過ぎ (ウェッジⒶがウェッジⒷの直上)

4) パネルが開き過ぎている場合は、以下の要領で左右パネルを引き寄せる。

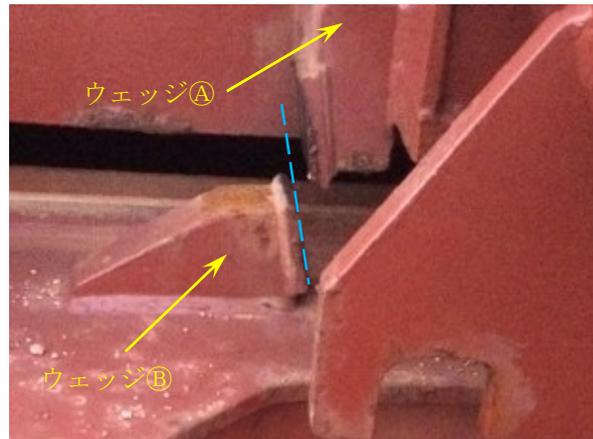
適切 (ウェッジⒶがウェッジⒷより内)

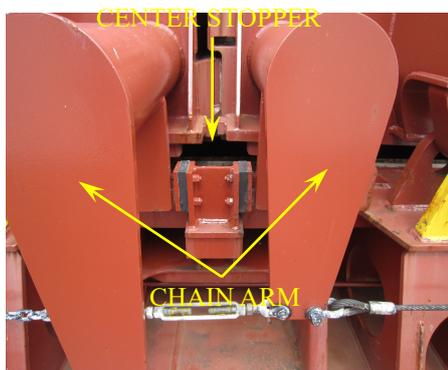
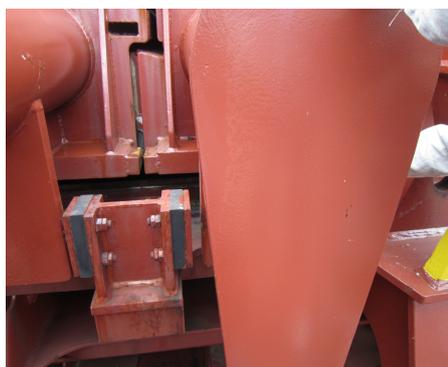
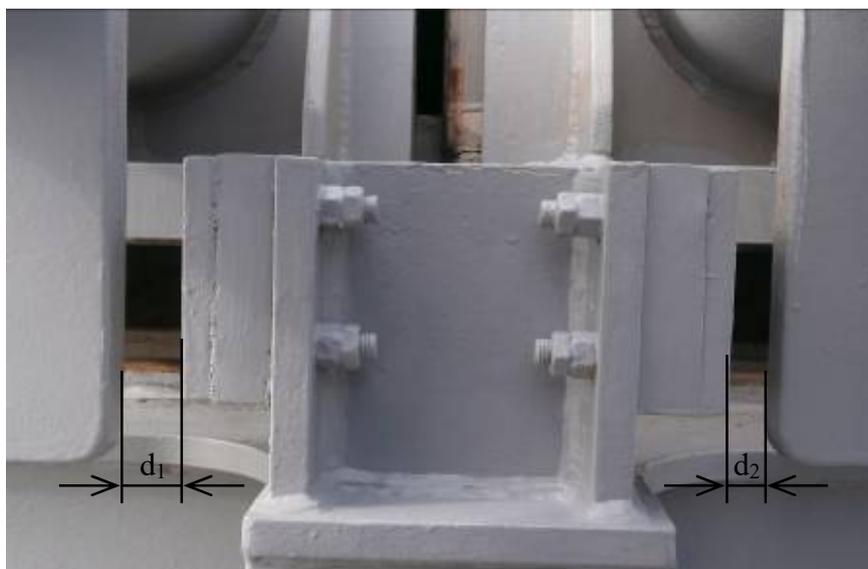
- 1) Operate manual valve, close port and starboard panel, and check whether the distances from center stopper to chain arm are equal on both sides., left and right.

Left Upper Photo : Aftward

Left Lower Photo : Forward

Right Photo : Distances between Center Stopper and Chain Arm =  $d_1$  ,  $d_2$

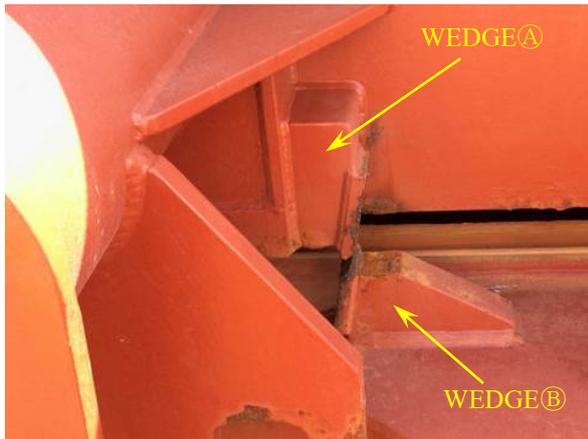
No Good (Wedge A is just above Wedge B)

4) If two panels are too distant, as shown in the left photo above, adjust them toward the center direction as follows.

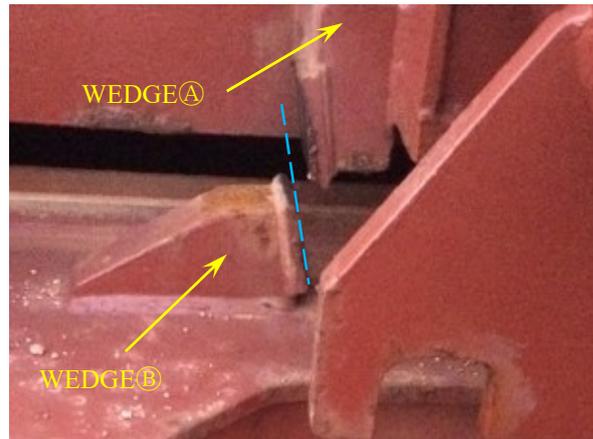
OK (Wedge A is inner comparing to Wedge B)
