## サイドローリングタイプハッチカバーの下降時の開きについて (1)

## Splitting Motion while Jacking down (1)

## Adjustment Manual for Positioning of Jack Head

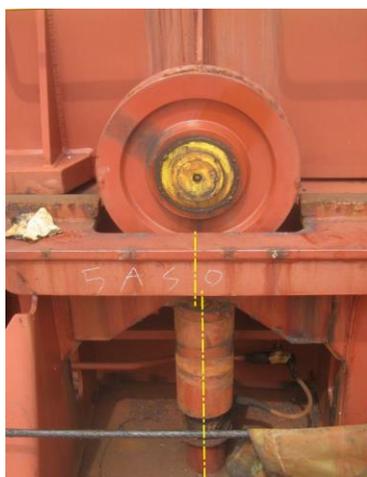
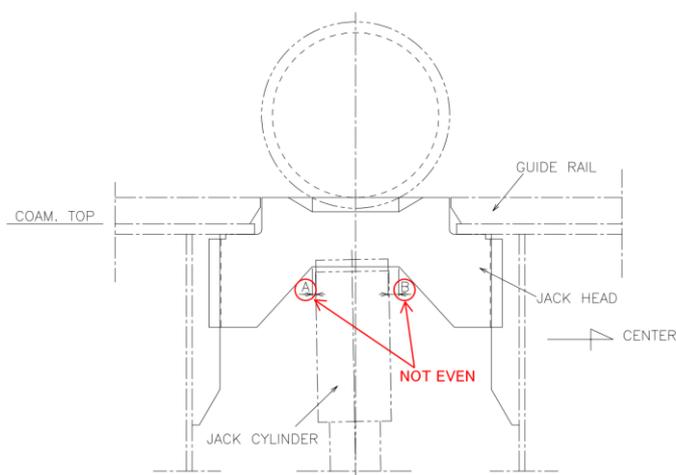
サイドローリングタイプハッチカバーは昇降動作を繰り返すことで、ジャッキシリンダーの軸心とジャッキヘッドの中心線とがズレてまいります。明らかなズレが視認される場合、以下手順にてご調整ください。

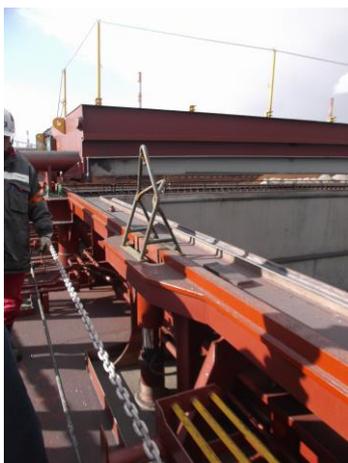
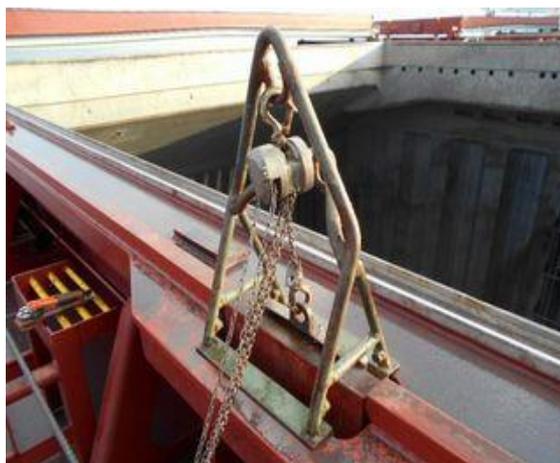
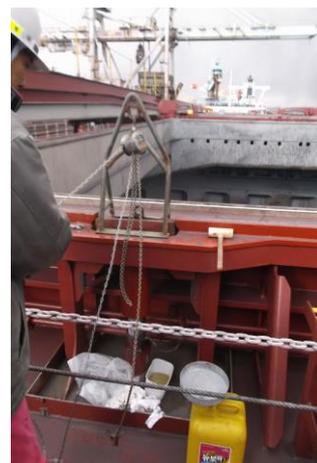
- 1) 昇降操作用マニュアルバルブを DOWN に切り替えた状態で、しばらく放っておく。
- 2) ジャッキヘッド吊り下げ架台（添付参考図 a 参照）をコーミング上に準備し、チェンブロックを巻き上げてジャッキヘッドをわずかに吊り上げる。

- 3) ジャッキヘッドとジャッキシリンダーが固着している場合は、ジャッキ頂部を銅ハンマーなどで叩いて離す。  
※ 誤って空気抜きを叩かないように注意する。
- 4) 銅ハンマーで叩くなどしてジャッキヘッドの中心線とジャッキシリンダーの軸心とが一直線上になるように調整し、チェンブロックを巻き下げてジャッキヘッドをジャッキシリンダーの上に戻す。
- 5) ジャッキヘッド吊り下げ架台を片付ける。

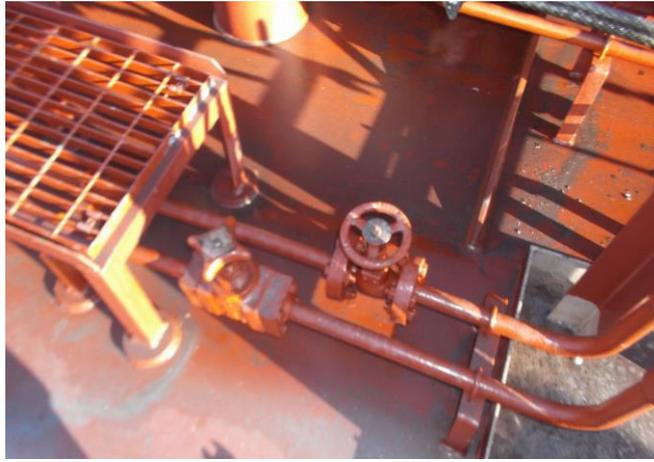
1-2) 調整するハッチのコントロールスタンド手前のストップバルブを閉める。

※ 先に高圧側（角フランジ）のストップバルブを閉じ、昇降操作用マニュアルバルブを UP⇔DOWN に数回切り替えてジャッキシリンダー内の残圧を低圧側に逃がした後、低圧側（丸フランジ）のストップバルブを閉じる。

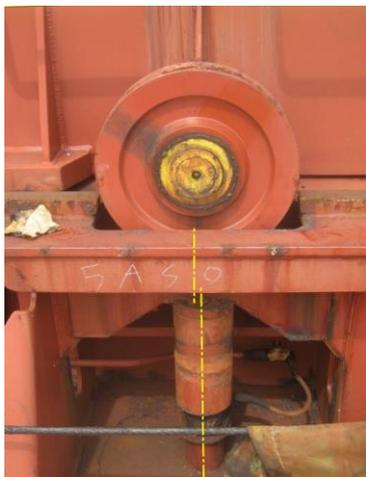
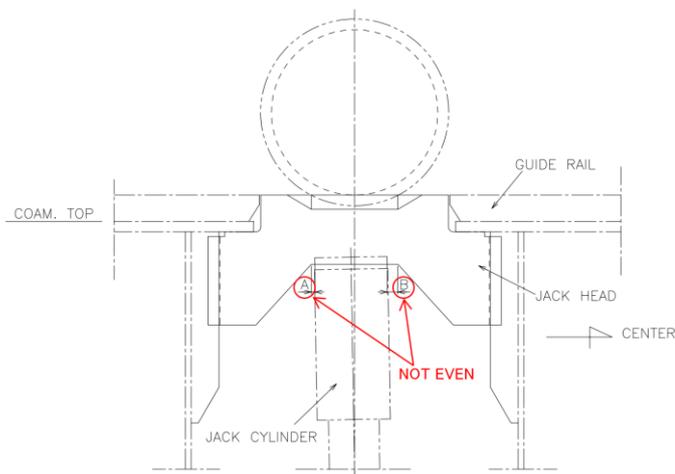
Regarding the side rolling type hatch cover, jack head's center line and jack cylinder axis can be misaligned due to repeated jack up/down operations. When obvious misalignment is found, readjust it according to the following procedure below.

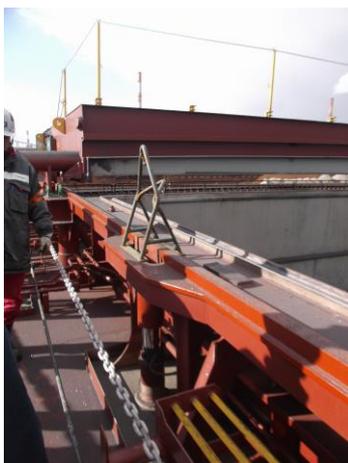
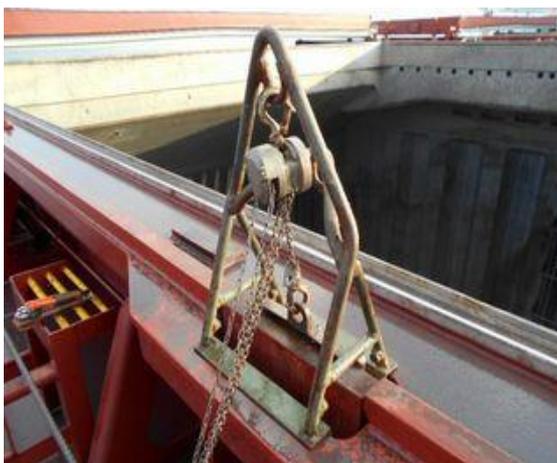
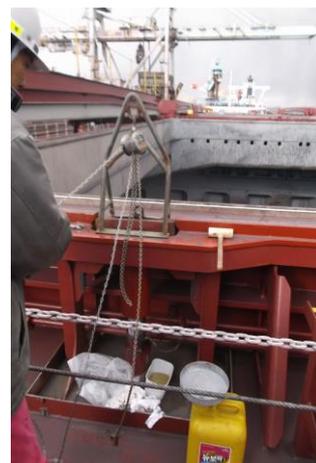
- 1) Wait for a while after shifting manual valve lever for "LIFTING" to "DOWN".
- 2) Set up the jack head hanger (refer to appendix "a") on coaming top around the jack head. Roll up chain block hung on jack head hanger and lift the jack head slightly.

- 3) If the jack head is stuck with the jack cylinder top, hit the top with copper hammer and separate them.
  - ※ Take care not to hit the air vent plug of the jack cylinder.
- 4) Adjust the alignment between the jack head center line and jack cylinder axis using a copper hammer. Roll down the chain block and restore jack head back on the jack cylinder top.
- 5) Remove the jack head hanger.

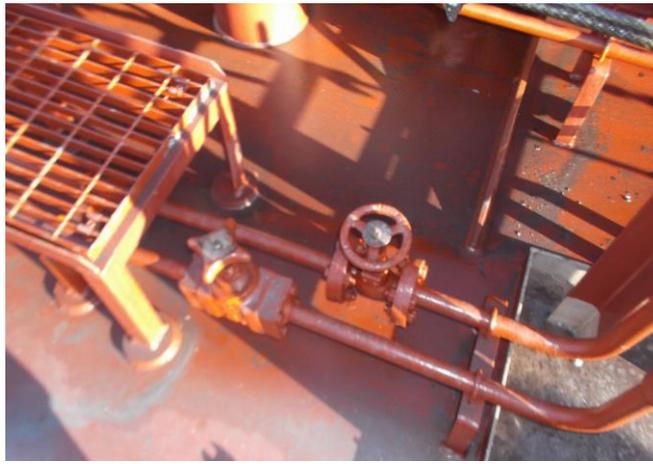
1-2) Close the stop valves near the control stand.

Remark: Close the stop valve of the pressure line (square flanged type) first. Then, shift the manual valve lever for “LIFTING” to “UP” AND “DOWN” several times to relieve remaining pressure. Lastly, close the stop valve of the tank line (circular flanged type).

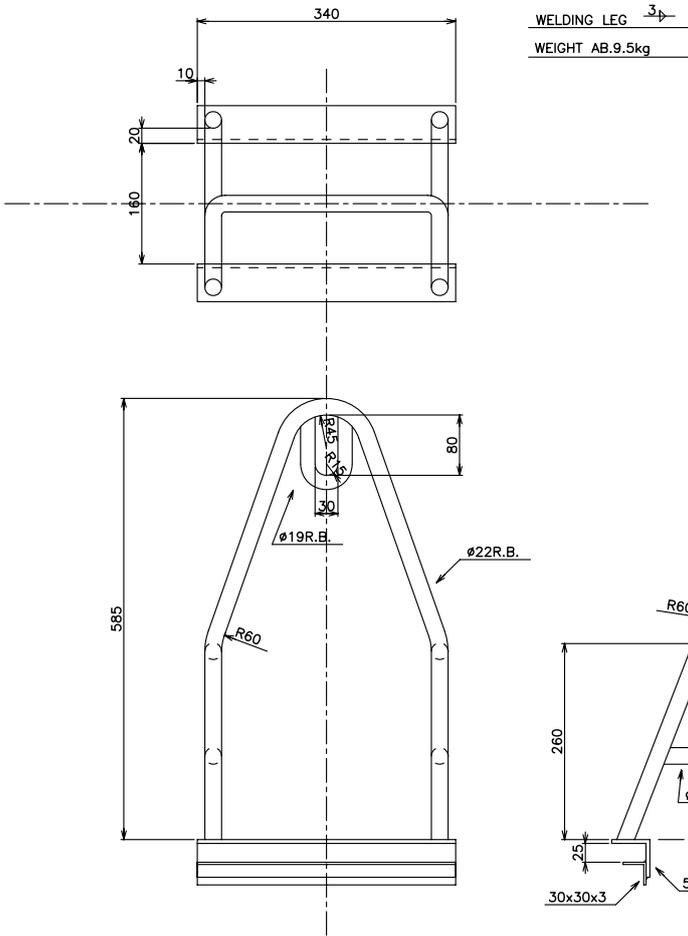
ITEM. NO.1

# JACK HEAD HANGER
