## サイドローリングタイプハッチカバーの下降時の開きについて

## チェーン&ワイヤーの調整方法

## Splitting Motion while Jacking down (2)

## Adjustment Manual for Balancing the Tension of Chain & Wire

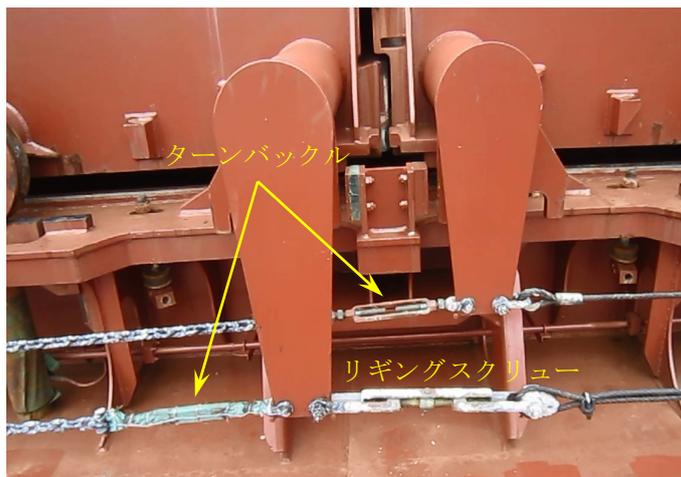
サイドローリングタイプハッチカバーは開閉動作を繰り返すことで、チェーン&ワイヤーの張りが不均衡になる場合があります。その場合には、以下の手順でチェーンに付くターンバックルとワイヤーに付くリギングスクリーを調整し、不均衡を解消してください。

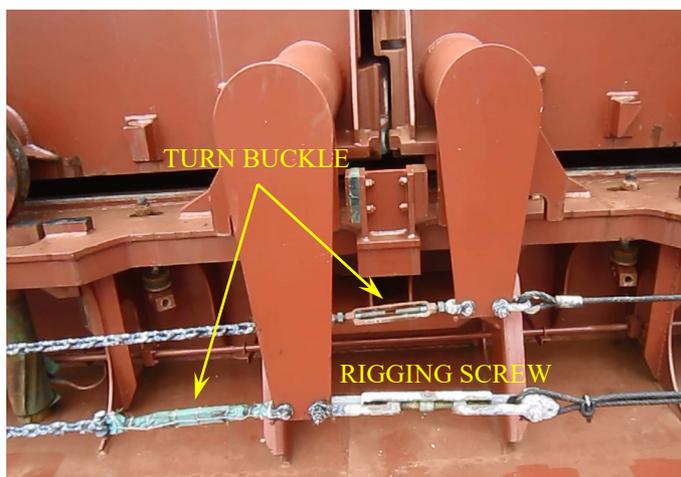
The frequent opening / closing operation of side rolling type hatch cover could cause an imbalance in the tension of the chain & wire. If so, follow the procedure below for adjusting turnbuckles at the end of chain and rigging screw at the end of wire to eliminate the imbalance.
