重大事故につながる操作について（中間保持）

Hatch cover operation that could lead to serious accidents (Partial opening)

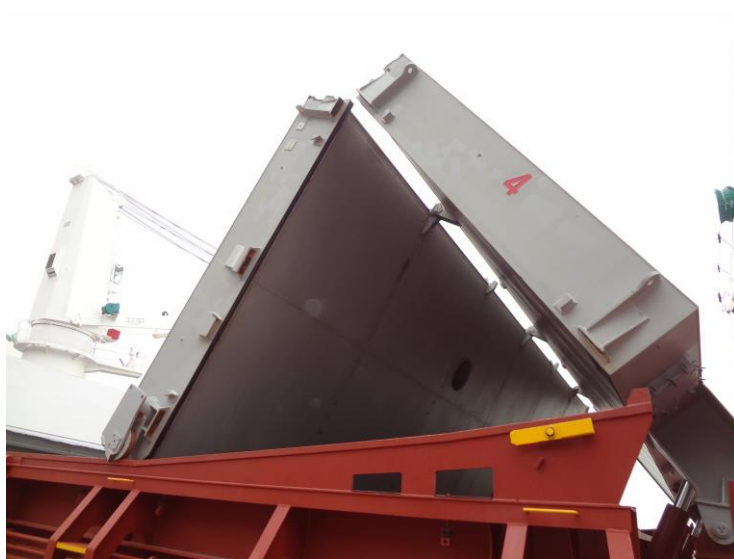
写真 1

湾港等比較的波が穏やかなエリアで艀内の掃除等の際にエンドフォールディングタイプハッチカバーを途中で停止させている光景を見受けられることが多々あります。通常取説に記載の通り、ハッチカバーの開閉については最終地点までの全開、全閉にすることを推奨しております。ホイールを固定させる金物をガイドレールに取り付けせず、中間停止させますとコントロールスタンド、シリンダーの内部リークによりハッチカバーが閉のほうへ動くことになり大変危険です。本件についてはRight SHIP8.9にも記載あります。もし中間保持を希望されるお客様がおられれば、油圧装置の改造、またガイドレールへの中間ストッパーの部品見積もりも可能です。お気軽にお問い合わせください。

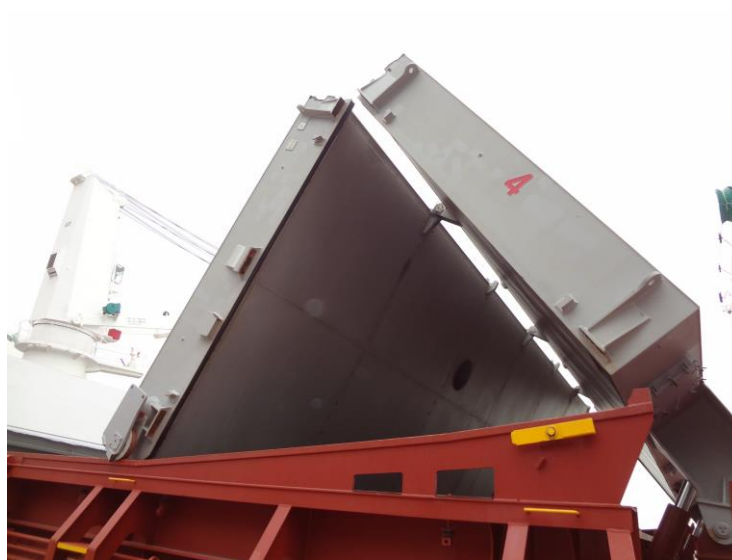
In areas where the waves are relatively calm, such as bay ports, we often see the end-folding type hatch cover stopped in the middle position (partially open) especially when cleaning operation is done inside the cargo hold area. As stated in the instruction manual, it is advised/recommended that the hatch cover should be operated fully open or fully close. Further, a hardware is provided to secure the wheel rigidly in place upon fully open position. During the state that the hatch cover is partially open and without any securing means, closing movement is high in possibility due to internal leakage of the control stand and its hydraulic cylinders. Thus, posing danger on its surroundings and operation, as also described in Right ship 8.9.

Photo 1) Hatch cover partial opening

But if partial opening is strongly requested, we can modify/change the hydraulic system and add portable stoppers to guide rails. Corresponding cost estimate can also be provided for the mentioned modifications upon contacting.
